Case Study – Lead Solder

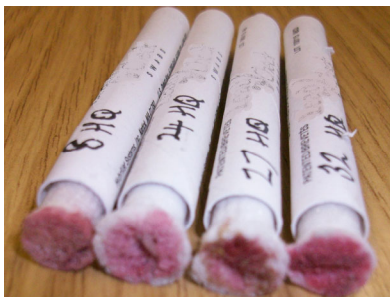
A 'Lead Check Swab' test kit was used to confirm the inspector's suspicions after it turned pink.

Positive lead tests

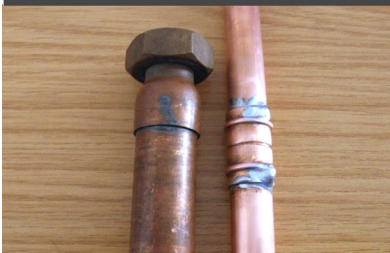
The inspections revealed drinking water was being distributed from a ground floor storage cistern to each apartment via a central large bore copper pipe system that used a solder free crimped jointing system. With each apartment's plumbing system made up of plastic pipes, it was difficult to see where any lead could leach from. The source was eventually tracked down to a small section of pipework, with only 5-6 soldered joints, at the point of entry into a utility room in each apartment. The solder on these joints had the same dull grey appearance as those seen on the central heating system.

22mm pipe with lead solder and 15mm pipe with lead free solder

Improvement Notices were subsequently issued to the service agents paying the water bill who promptly challenged the developer to carry out all remedial actions. Due to the number of other contractors involved in the development identifying who carried out the work proved impossible for the water company which has delayed remediation works. Samples of the pipe work were removed by the installer for analysis which proved lead solder was used. Further delays occurred after the intervention of the Resident's Association following boiler breakdowns after some remedial works were carried out. Only 11 apartments have so far been completed because of this, but all soldered joints are being replaced with mechanical joints.

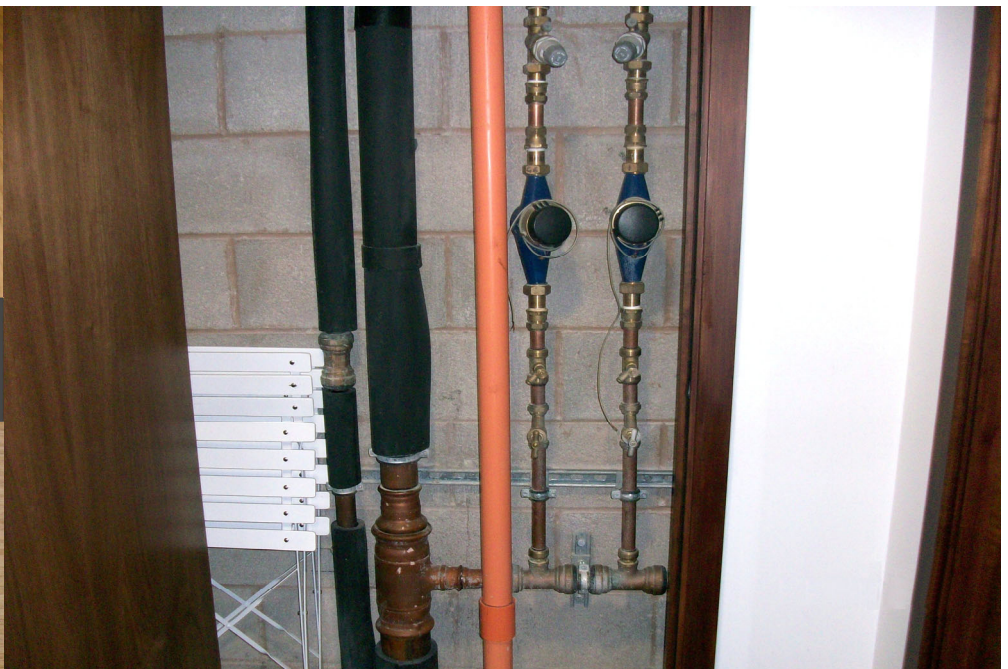
Pipework feeding the apartments installed correctly
